**Flood Control Project Maintenance
Levee Inspections**
LMA District Cover Sheet
Spring 2019 Levee Inspection Results

Reclamation District No. 2060 Hastings

Spring 2019 Levee Inspection Results

Waterway	Bank	Unit Miles
Unit No. 01 Lindsey Slough	Left	6.97

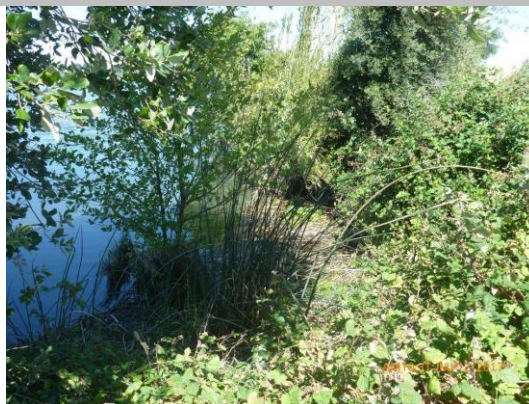
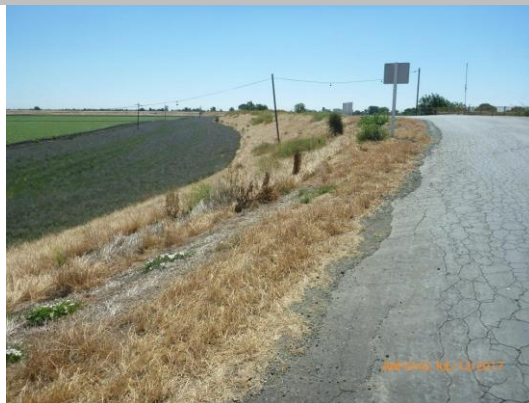
LM Start	0.40	Rating **	M	Issue No.	5
LM End	0.40	Issue Type +	Ma	Location *	WS
Category	Supplemental			GPS Latitude/Longitude	
				Start	End
Item	2017 Storm Damage			38.247894 °	38.247911 °
				-121.703492 °	-121.703539 °
DWR ID	DWR_RD2060_01_f _ 2017_5				
Comment Code					
Inspector Comment					
Levee Evaluation Comments					
Description:Erosion commences approximately 3/4 of the way down the slope, near the water line towards the waterside toe.					
Site ID No:358					
Site Designation:LMA-185					
Repair Type: Erosion					
Rating:Area of Concern					
Field Date:7/12/2017					
Notes: Small erosion into bank.

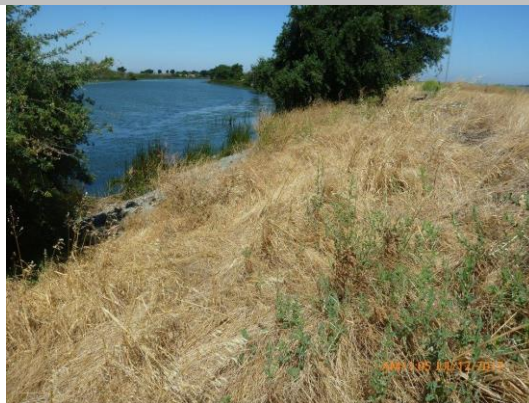
Photo 3 of 3 : SP_2019_RD2060_241_8_20190311_00009.jpg

LM Start	0.41	Rating **	M	Issue No.	8 (cont)	
LM End	0.42	Issue Type +	Ma	Location *	WS	
Category	Supplemental			GPS Latitude/Longitude		
				Start	End	
Item	2017 Storm Damage			38.248036 °	38.248017 °	
				-121.703539 °	-121.703789 °	
DWR ID	DWR_RD2060_01_f_2017_8					
Comment Code						
Inspector Comment						
Levee Evaluation Comments						
Description:Erosion commences approximately halfway down the water side slope extending in to existing rip rap. Existing rip rap appears to have been pulled off in this section.						
Site ID No:359						
Site Designation:LMA-186						
Repair Type: Erosion						
Rating:Area of Concern						
Field Date:7/12/2017						
Notes: Site had riprap but is eroded away. Minor erosion in toe of levee.

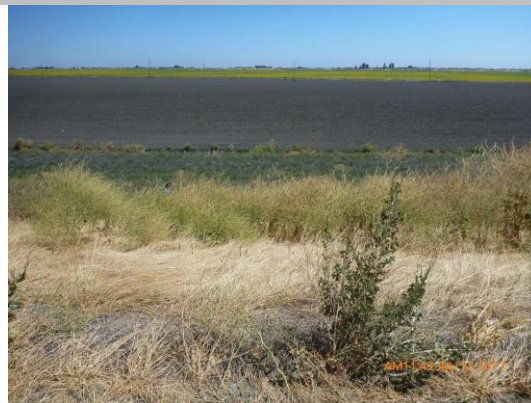
LM Start	0.75	Rating **	M	Issue No.	9
LM End	0.76	Issue Type +	Ma	Location *	WS
Category	Supplemental			GPS Latitude/Longitude	
				Start	End
Item	2017 Storm Damage			38.249314 °	38.249400 °
				-121.709461 °	-121.709608 °
DWR ID	DWR_RD2060_01_f_2017_9				
Comment Code					
Inspector Comment					
Levee Evaluation Comments					
Description:Erosion commences approximately halfway down the water side slope extending in to existing rip rap. Erosion is concentrated near the waterline. Existing rip rap appears to have been pulled off in this section.					
Site ID No:360					
Site Designation:LMA-187					
Repair Type: Erosion					
Rating:Area of Concern					
Field Date:7/12/2017					
Notes: Erosion looks old but has progressed this year.

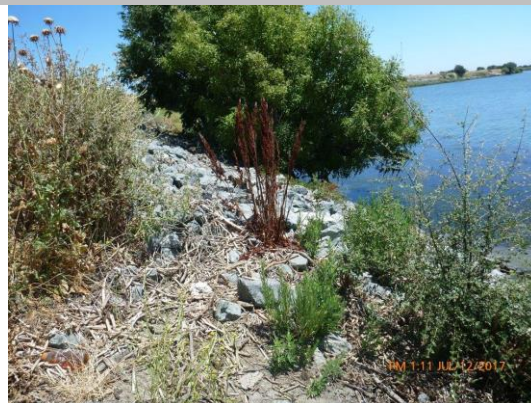
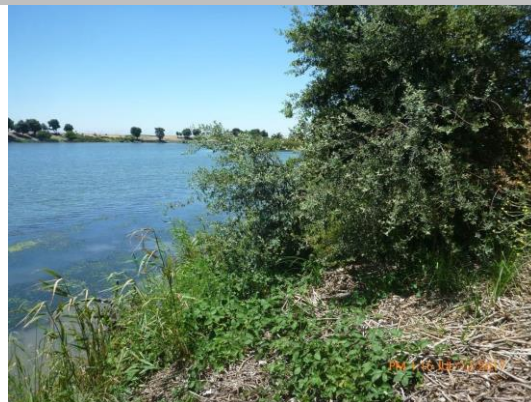
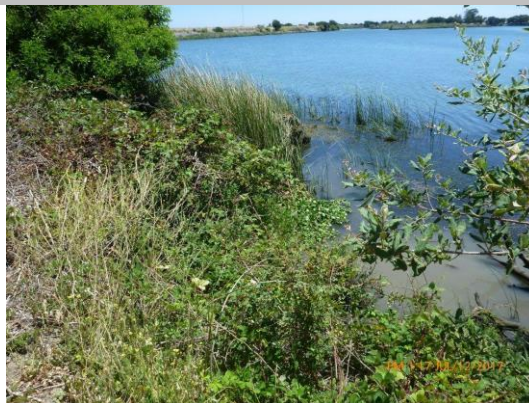
LM Start	1.04	Rating **	M	Issue No.	15
LM End	1.08	Issue Type +	Ma	Location *	WS
Category	Supplemental			GPS Latitude/Longitude	
				Start	End
Item	2017 Storm Damage			38.251058 °	38.250872 °
				-121.714050 °	-121.714792 °
DWR ID	DWR_RD2060_01_f_2017_15				
Comment Code					
Inspector Comment					
Levee Evaluation Comments Description:Erosion commences approximately 3/4 of the way down the water side slope concentrated at the waterline. Site ID No:362 Site Designation:LMA-189 Repair Type: Erosion Rating:Area of Concern Field Date:7/12/2017 Notes: Erosion due to lack of revetment. Erosion ends at riprap downstream. Vertical cut at summer wse.

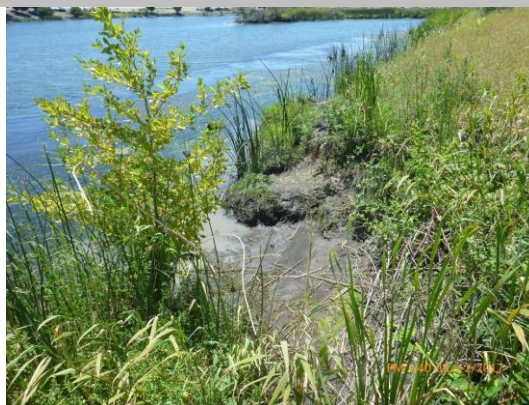
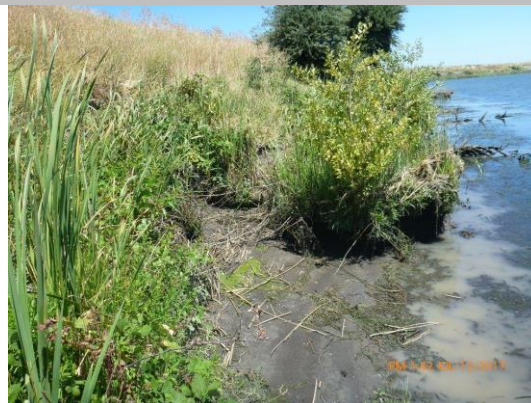
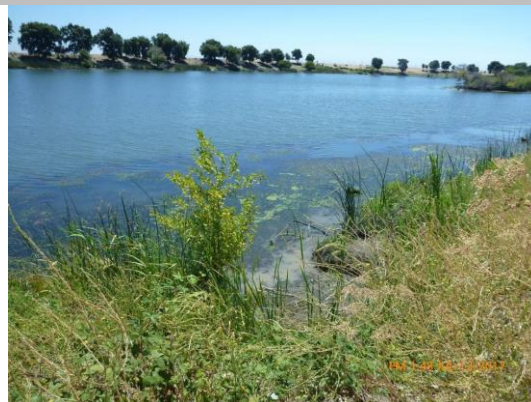
LM Start	1.09	Rating **	M	Issue No.	16
LM End	1.10	Issue Type +	Ma	Location *	WS
Category	Supplemental			GPS Latitude/Longitude	
				Start	End
Item	2017 Storm Damage			38.250844 °	38.250833 °
				-121.714944 °	-121.714994 °
DWR ID	DWR_RD2060_01_f_2017_16				
Comment Code					
Inspector Comment					
Levee Evaluation Comments Description:Erosion commences approximately halfway down the water side slope extending to the toe. Site ID No:363 Site Designation:LMA-190 Repair Type: Erosion Rating:Area of Concern Field Date:7/12/2017 Notes: Small erosion up to high water line. Cuts into slope with 6' vertical cut.

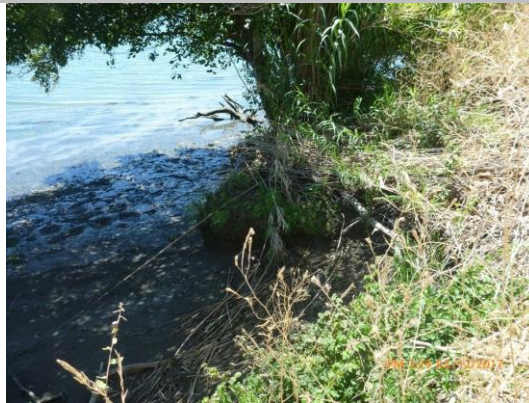
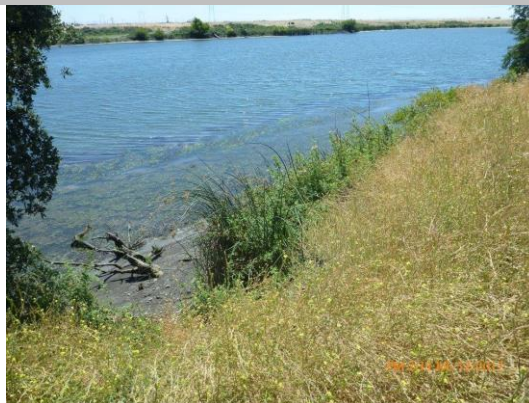
LM Start	1.39	Rating **	A/W	Issue No.	20
LM End	1.56	Issue Type +	Ma	Location *	WS
Category	Supplemental			GPS Latitude/Longitude	
				Start	End
Item	2017 Storm Damage			38.251886 °	38.252619 °
				-121.719933 °	-121.722842 °
DWR ID	DWR_RD2060_01_f_2017_20				
Comment Code					
Inspector Comment					
Levee Evaluation Comments					
Description:Erosion commences approximately halfway down the water side slope extending to the toe.					
Site ID No:365					
Site Designation:LMA-192					
Repair Type: Erosion					
Rating:Serious					
Field Date:7/12/2017					
Notes: Several deep narrow cuts into levee, but mostly minor erosion at highwater line.

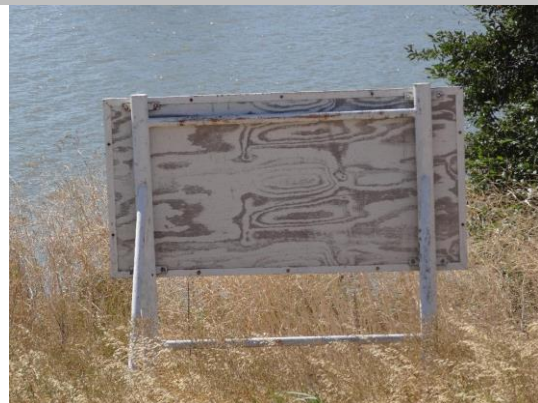
Photo 1 of 2 : UCIP_SP_2019_41908_30541.jpg

WS view: gasoline sign board on levee slope.

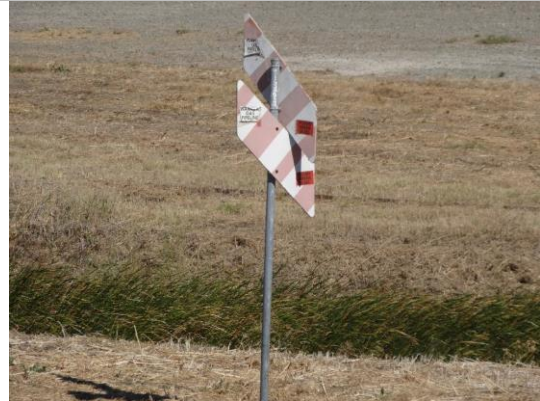
Photo 2 of 2 : UCIP_SP_2019_41908_30540.jpg

LS view: gasline indicator across the road from levee toe.

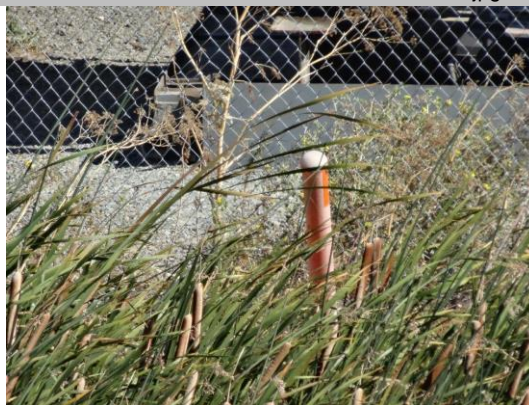
Photo 2 of 3 : UCIP_SP_2019_41878_30548.jpg

LS view: closer view of gasline indicator found on LS.

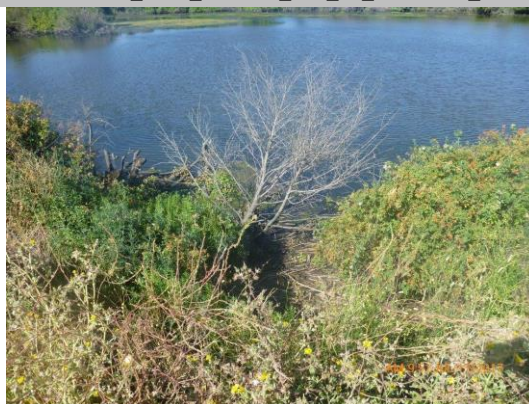
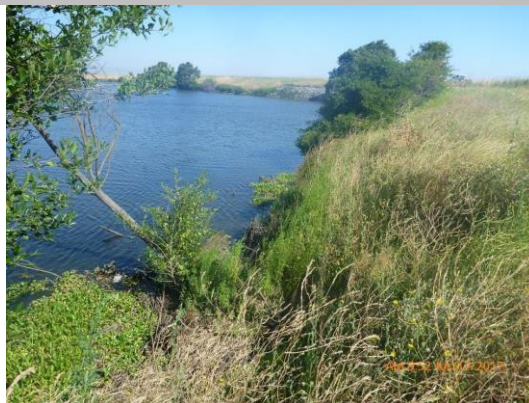
LM Start	4.80	Rating **	A/W	Issue No.	32
LM End	4.88	Issue Type +	Ma	Location *	
Category	Supplemental			GPS Latitude/Longitude	
				Start	End
Item	2017 Storm Damage			38.260714 °	38.261808 °
				-121.767972 °	-121.768536 °
DWR ID	DWR_RD2060_01_f_2017_32				
Comment Code					
Inspector Comment					
Levee Evaluation Comments					
Description:Erosion/sloughing commences approximately halfway down the slope. Erosion is concentrated mostly near the water line and has resulting in slippage of the slope towards the toe.					
Site ID No:379					
Site Designation:LMA-206					
Repair Type: Erosion					
Rating:Serious					
Field Date:7/17/2017					
Notes: Several erosions with slumping. Fresh soil indicates active erosion this season. Adjacent slope has riprap. Riprap should be extended along this stretch.

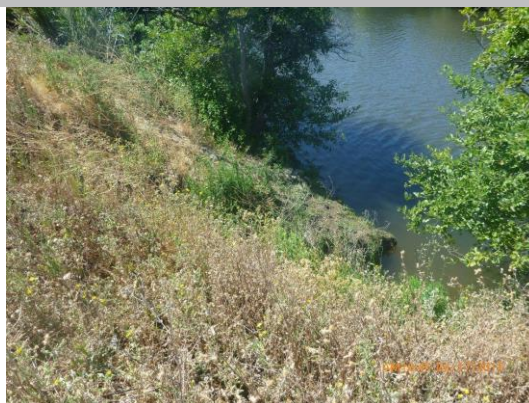
Photo 1 of 3 : SP_2019_RD2060_241_34_20190311_00065.jpg

LM Start	5.00	Rating **	M	Issue No.	34
LM End	5.01	Issue Type +	Ma	Location *	
Category	Supplemental			GPS Latitude/Longitude	
				Start	End
Item	2017 Storm Damage			38.262636 °	38.262658 °
				-121.770503 °	-121.770547 °
DWR ID	DWR_RD2060_01_f_2017_34				
Comment Code					
Inspector Comment					
Levee Evaluation Comments					
Description:Erosion is concentrated mostly near the water line and has resulting in slippage of the slope into the toe.					
Site ID No:381					
Site Designation:LMA-208					
Repair Type: Erosion					
Rating:Area of Concern					
Field Date:7/17/2017					
Notes: Extended site from 15' to 75' to include LMA-209. Small erosions will become 1 site next high water due to sloughing between them.

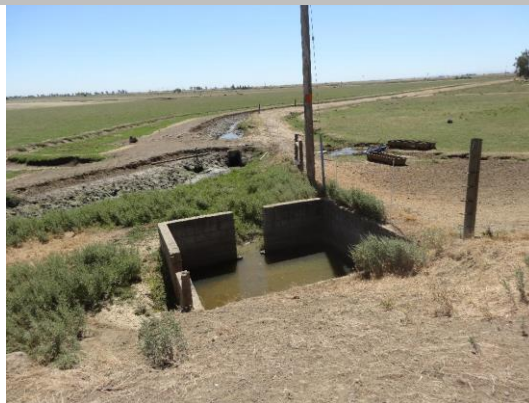
Photo 2 of 2 : UCIP_SP_2019_46769_31087.jpg

LS view: abandoned concrete distribution box. Not accessible due to wire fence.

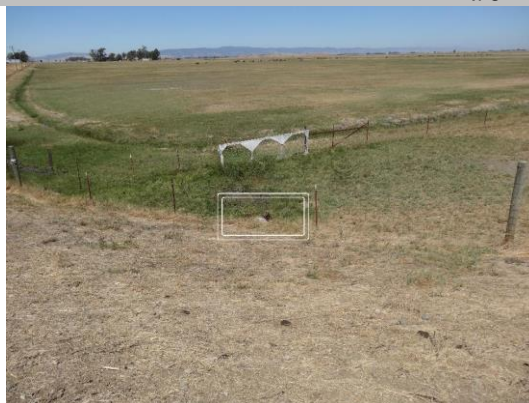
Photo 1 of 3 : UCIP_SP_2019_18386_30873.jpg

WS view: overview of CMP from levee.

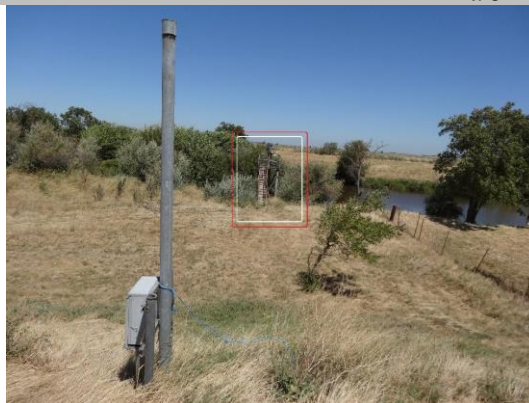
Photo 1 of 3 : UCIP_SP_2019_41668_31161.jpg

WS view: electrical box on pole and pump structure in background.

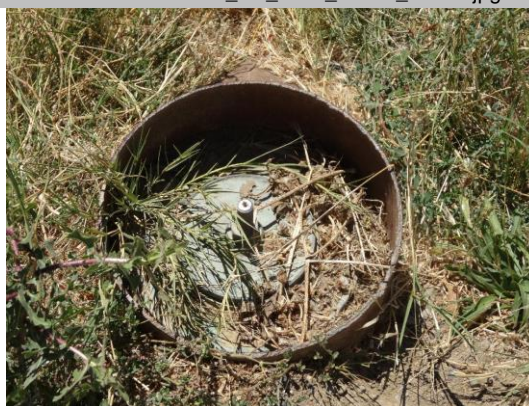
Photo 3 of 3 : UCIP_SP_2019_41668_31163.jpg

LS view: obstructed siphon breaker in steel riser on levee slope.

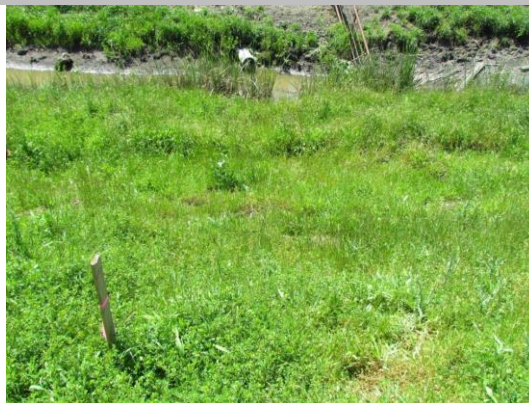
Photo 1 of 2 : SP_2019_RD2060_243_16_20190311_00010.jpg

Looking down from the shoulder at the sloughing in the slope towards the irrigation ditch at toe.

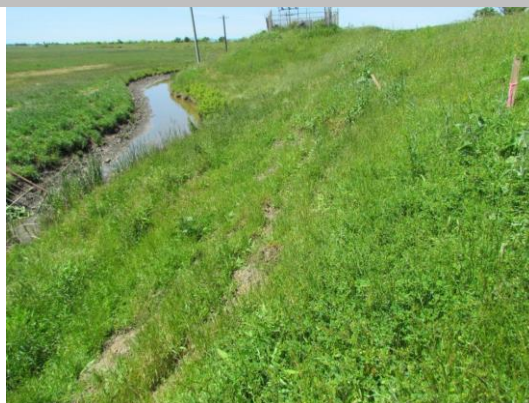
Photo 2 of 2 : SP_2019_RD2060_243_16_20190311_00011.jpg

Standing on the slope looking upstream at the slough.

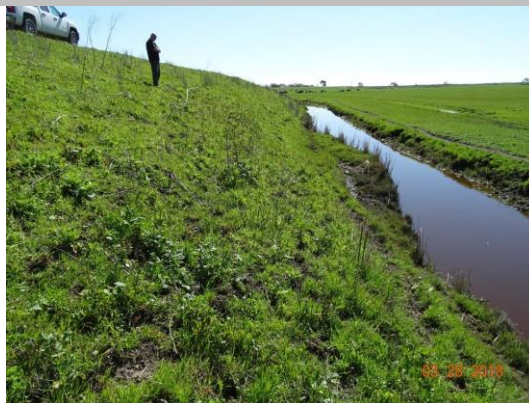
Photo 1 of 1 : SP_2019_RD2060_243_71_20190311_00079.jpg

Lower landside slope has slumped into ditch. Should be repaired.

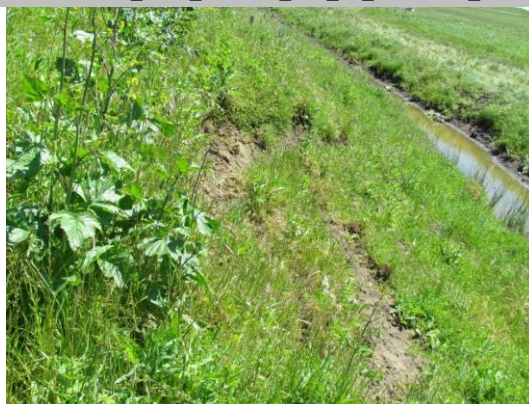
Photo 1 of 2 : SP_2019_RD2060_243_19_20190311_00014.jpg

LM Start	0.15	Rating **	A/W	Issue No.	19
LM End	0.19	Issue Type +	Ma	Location *	LS
Category	Earthen Levee			GPS Latitude/Longitude	
				Start	End
Item	Slope Stability			38.295738 °	38.295559 °
				-121.746293 °	-121.745583 °
DWR ID	DWR_RD2060_03_s_2017_19				
Comment Code					
S1 : Repair slope instability.					
Inspector Comment					
There are several signs of sloughing occuring on the slope.

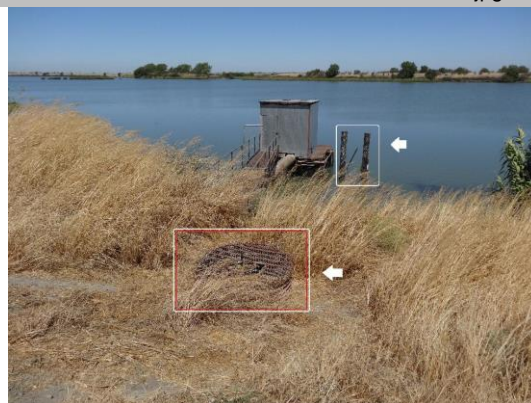
WS view: slide gate in CMP riser (bottom- marked) and may be abandoned pile for pump support (marked- right).
